EARTHQUAKE INDUCED FISSURING IN BANKS
PENINSULA LOESSIAL SOILS: A GEOTECHNICAL
INVESTIGATION OF THE RAMAHANA ROAD FISSURE
TRACE

A thesis submitted in partial fulfilment
of the requirements for the Degree of
Master of Science in Engineering Geology
In the Department of Geological Sciences
University of Canterbury

Christopher Stuart White

2016

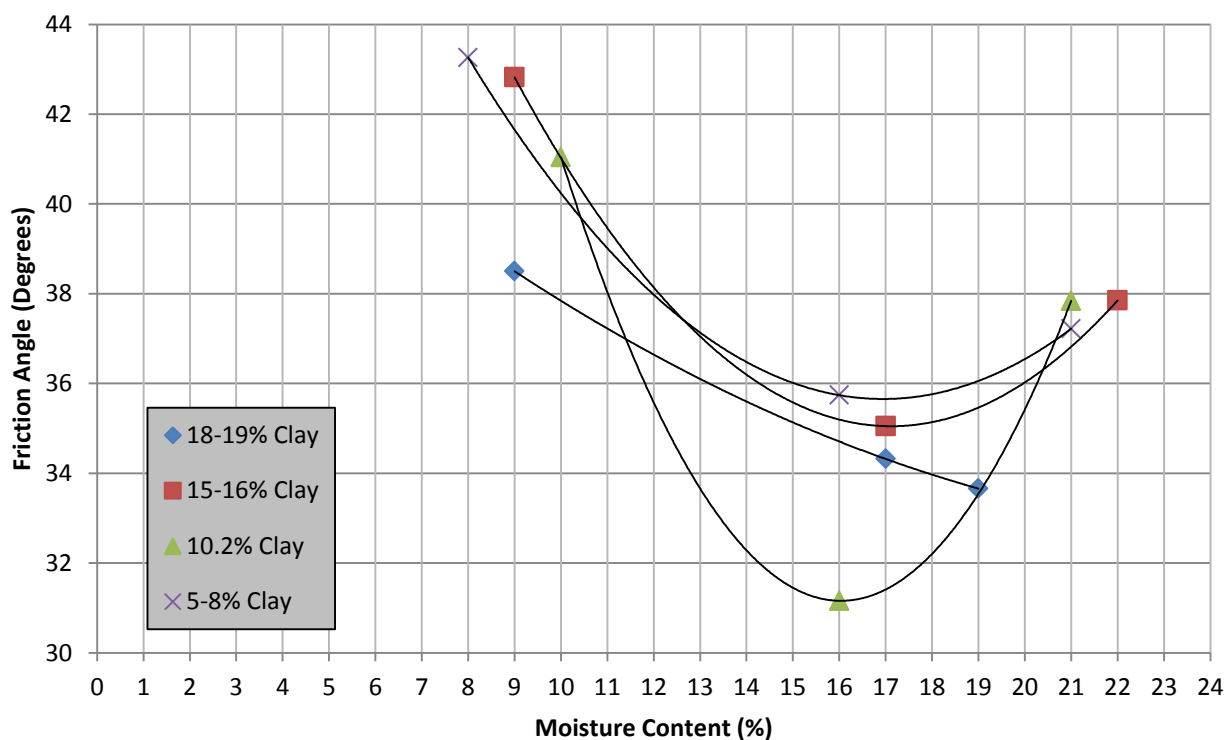
The friction angles of the sample were less clearly affected by the moisture content. Figure 4.15 shows the relationship between friction angle and moisture content for samples of varying clay contents. The friction angle has been recorded to decrease under increasing moisture contents until ~19% moisture content, and then increases at 21-23% moisture content. The reasons for this are unclear, but perhaps suction and capillary action have a greater effect on friction angle at higher moisture contents.

Figure 4.15: The friction angle with moisture content for soil samples of various clay contents as tested by the direct shear-box strength test. Trendlines are polynomial.

There is a considerable amount of scatter in this relationship, and the trends are not as obvious as in the relationship between cohesion and moisture content. The clay content does not appear to have a major effect on the friction angle, but the moisture content appears to have some affect. The scatter and variability can be attributed to the reconsolidated nature of

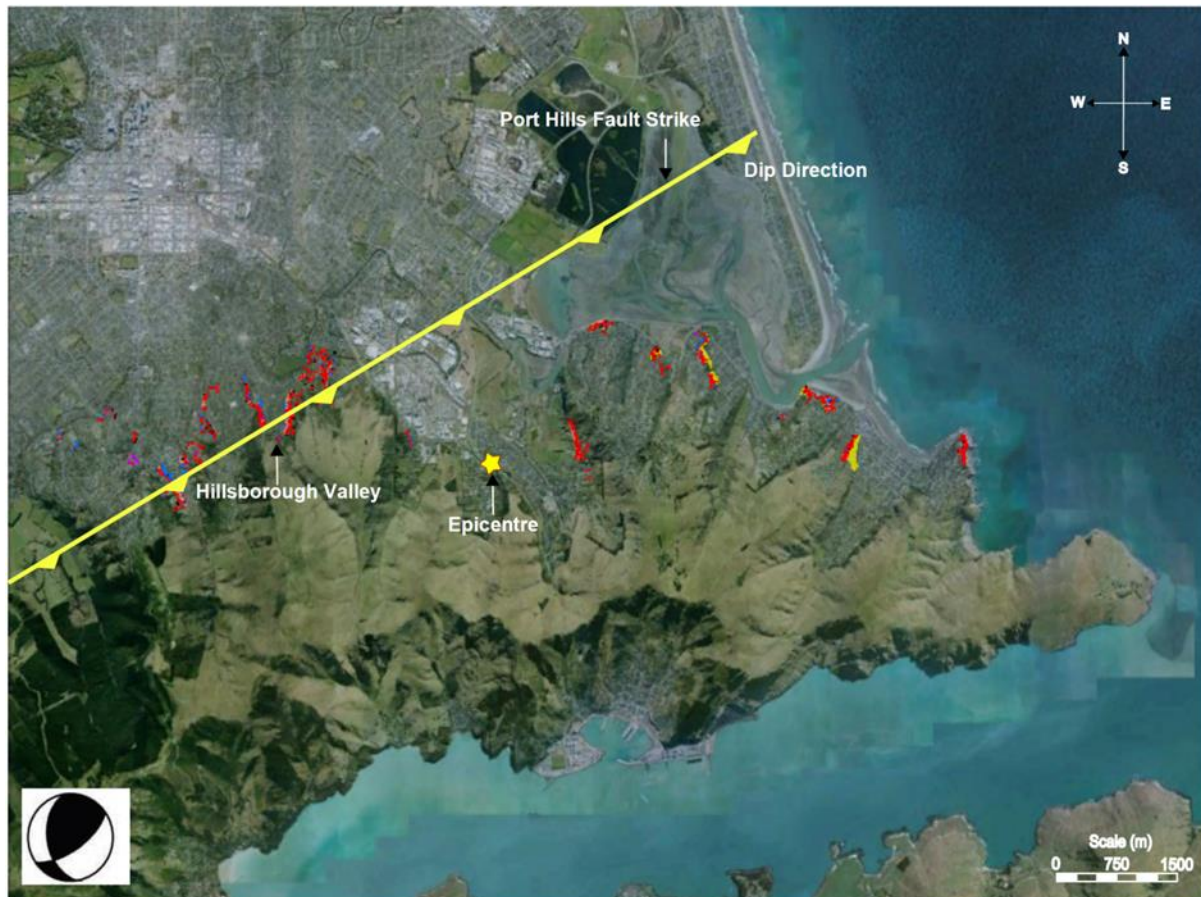
0.85g vertical peak acceleration and 0.35 and 0.40 peak orthogonal horizontal components were recorded (Kaiser et al. 2012) at Cashmere High School, which was the nearest GeoNet station to 17 Ramahana Road (~2.5 km to the west). Figure 5.2 is a model of the orientation and location of the Port Hills Fault and epicentre of the 22 February, 2011 Christchurch Earthquake, in relation to the location of the fissure traces. The fissure traces are all located on the north facing valleys within 7km of the earthquake epicentre. This suggests that high ground shaking intensity was needed to induce the fissure trace movement.

Nearly all of the fissures form upslope from Lyttelton Volcanic Group valleys which have been in-filled with loess-colluvium and valley alluvium, and there are two compelling reasons as to why this could be so. The first is that there is a greater thickness of loess-colluvium at the toe of the slopes which means there is more potential for the loessial soil to

accumulate strain, and simply more loessial soil that could be affected by cyclic stress. The second reason is that the in-filled valleys have a higher moisture content than on steeper slopes due to the effects of drainage. The higher moisture content in the valleys suggests that there is a greater potential for plastic deformation.

Figure 5.2: Fissure traces in relation to the 22nd of February 2011 Christchurch Earthquake epicentre and Port Hills fault. Fissure traces mapped by Massey et al. (2013), map modified from Project Orbit. Fault orientation and location after Kaiser et al. (2011).

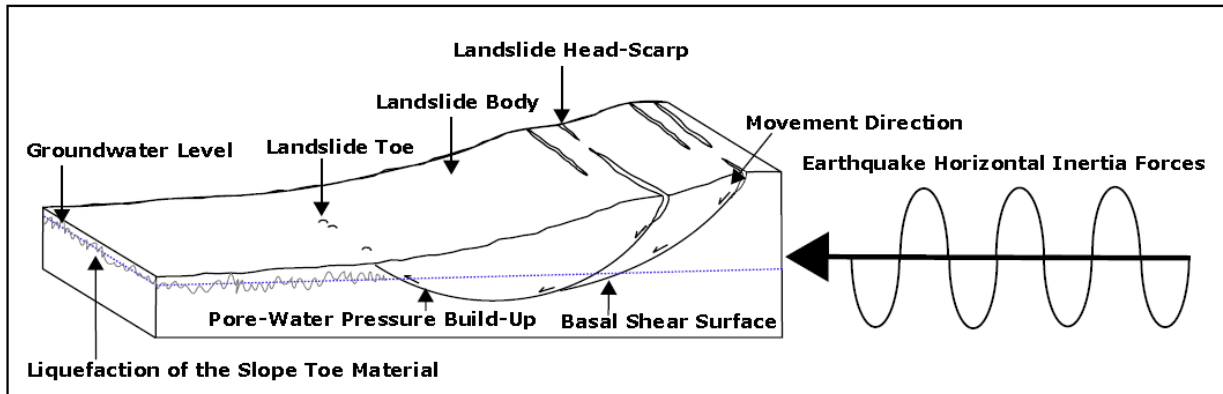
Figure 5.4 is a block model of 17 Ramahana Road interpreting the fissure traces as being caused by sliding on a circular basal shear surface. The mechanisms involved in this movement are theoretical liquefaction of the slope toe material, and pore-water pressure build-up along a potential curved basal shear surface. The mechanisms of rotational slide

movement are very similar to that of translational slide failure, but it is the movement of the soil mass that is distinctly different when comparing the two landslide movement types due to the different shapes of the basal shear surface. The basal shear surface and movement depicted in Figure 5.4 does not show a good correlation to the surface features observed. Because translational slide movement is considered to be much more likely than rotational slide movement, these mechanisms are covered in more detail in section 5.5.2.

Figure 5.4: Rotational slide movement model. The slope, fissure traces, and compressional features are modelled from 17 Ramahana Road. The mechanisms of movement are hypothetical.

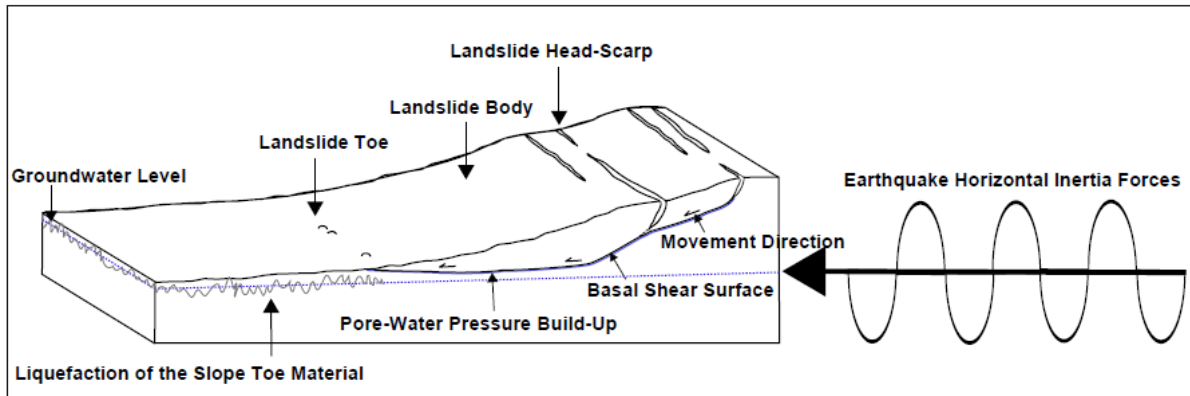
The translational slide model in Figure 5.6 incorporates the combined mechanisms of liquefaction of the slope toe (as suggested by Dellow et al. 2011) and pore-water pressure build-up along a potential basal shear surface. Under these combined mechanisms a basal

shear surface would form where the greatest increase in pore-water pressure was located, and where the greatest increase in shear stress was located. Horizontal earthquake inertia forces would also have been acting on the slope, and these would most likely have been the impetus needed to begin sliding on the basal shear surface.

Figure 5.6: Translational slide model. The slope, fissure traces, and compressional features are modelled from 17 Ramahana Road. The mechanisms of movement are hypothetical.

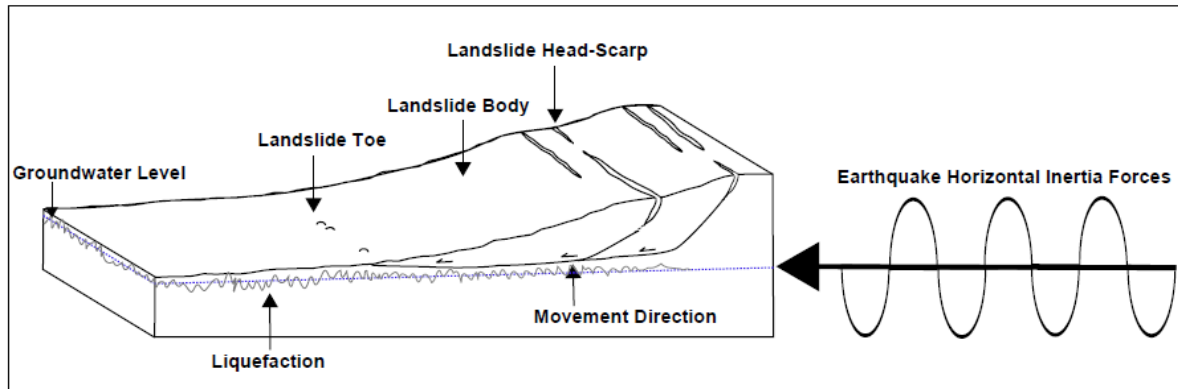
The lateral spread model in Figure 5.8 incorporates liquefaction of the loess-colluvium along the groundwater level. The base of displacement has been drawn as a definite line similar to the basal shear surface in the translational slide model. However, in a lateral spread type of movement the basal shear surface is poorly defined and occurs throughout the liquefied layer below, but this was not possible to draw. There are some elements of translational sliding in this model, but in contrast to the translational slide model it is purely the theoretical mechanism of liquefaction of the saturated material that causes a loss of shear strength in the soil. The earthquake horizontal inertia forces are the impetus needed to begin slope

movement by increasing the shear stress above the residual strength of the liquefied material. Due to the groundwater levels observed at 17 Ramahana Road extending into the slope rather than following the slope angle, the base of displacement becomes very deep at the upslope extent of fissuring.

Figure 5.8: Lateral spread model. The slope, fissure traces, and compressional features are modelled from 17 Ramahana Road. The mechanisms of movement are hypothetical.

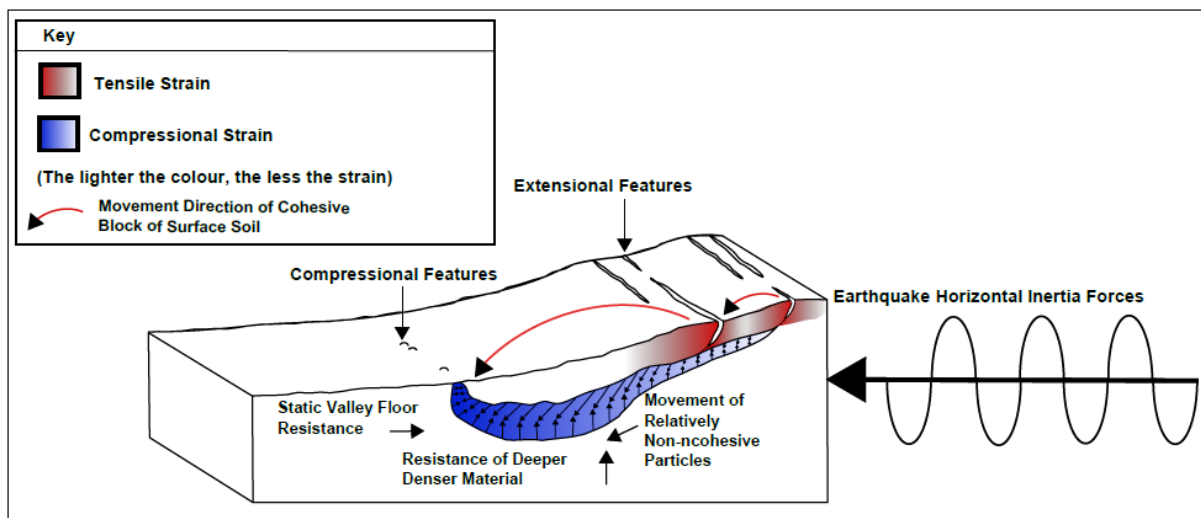
Figure 5.9: Tensile failure model. The slope, fissure traces, and compressional features are modelled from 17 Ramahana Road. The mechanisms of movement are hypothetical.

The tensile failure model in Figure 5.9 is an attempt to visually portray where the strain accumulated in the soil and how this dissipated upslope. In this model the earthquake horizontal inertia forces are the main mechanisms of movement because they lead to the compressional strain in the slope toe and tensile strain in the above material. Because this model is not portraying a typical landslide type movement, it does not use landslide terminology, and instead denominates the fissures as extensional features rather than landslide head-scarps. Likewise the compressional features are simply denominates as compressional features rather than the landslide toe. There is no translational zone in this model.

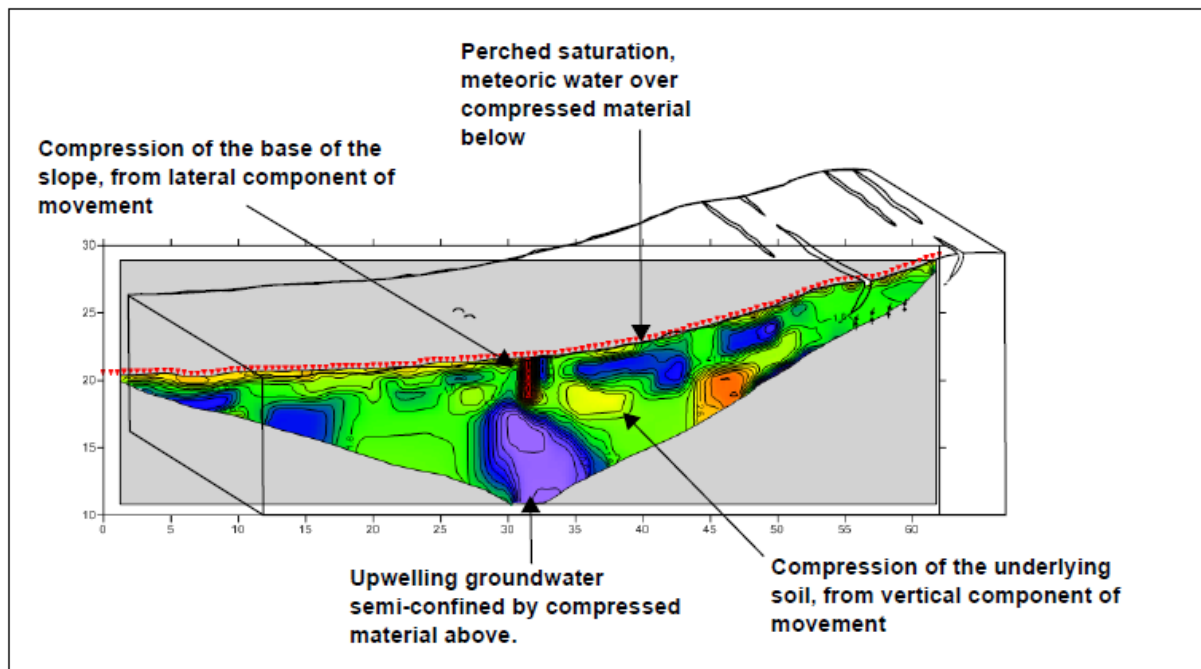
A block model with the electrical resistivity geophysical survey overlaid is presented in Figure 5.14. This diagram has the interpreted features of the resistivity anomaly pointed out. An attempt to visually portray the suggested mechanisms and movement is displayed in Figure 5.15. This suggested mode of movement can be considered a quasi-toppling mode of movement similar to that suggested by Stephen-Brownie (2012), but with different mechanisms.

Figure 5.14: Tensile movement model with the electrical resistivity geophysical survey and interpretations overlaid. Modelled from 17 Ramahana Road.

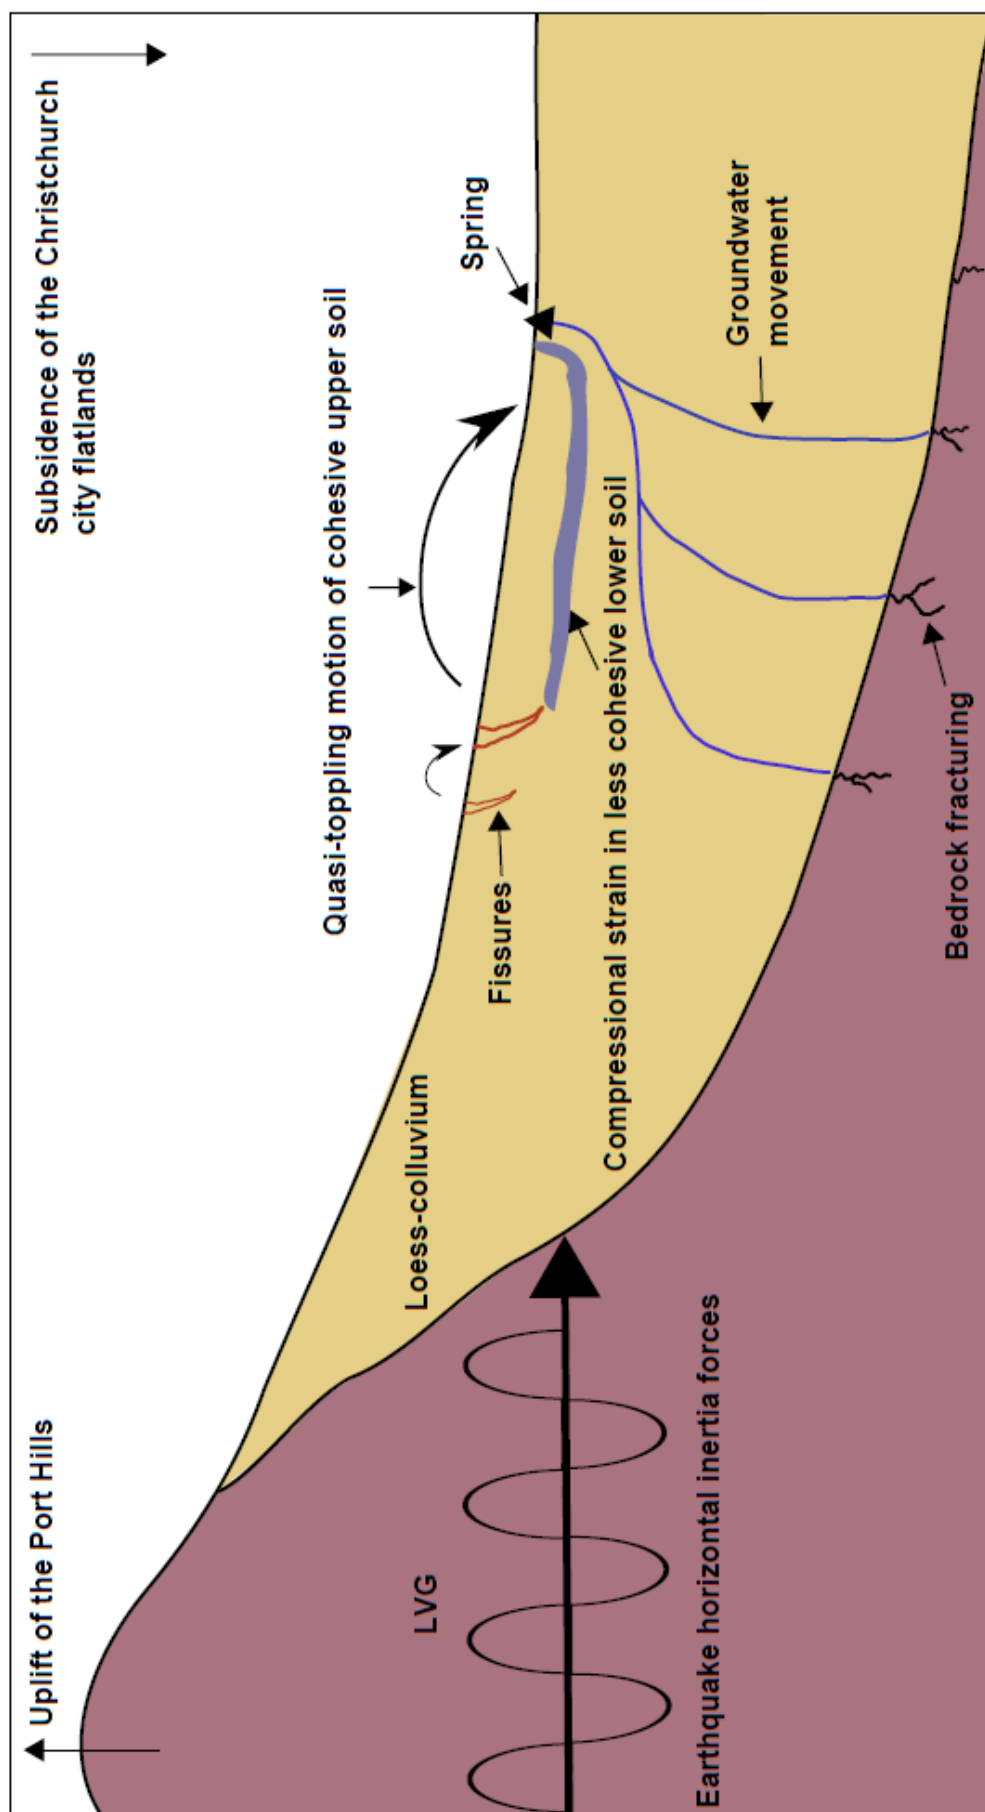
Figure 5.15: Diagram depicting the quasi-toppling motion of the surface soil and the compressional strain of the deeper soil, the horizontal earthquake inertia forces, the uplift of the Port Hills in relation to the Christchurch city flatlands, and the static shear stress from the slope. The generation of new springs at the base of the slope is from bedrock fracturing offering a new source of groundwater and an increased hydraulic head from compression of joints within the LVG. The springs form within the compressional zone due to the soil that has been under compressional strain retarding the upward movement of groundwater.

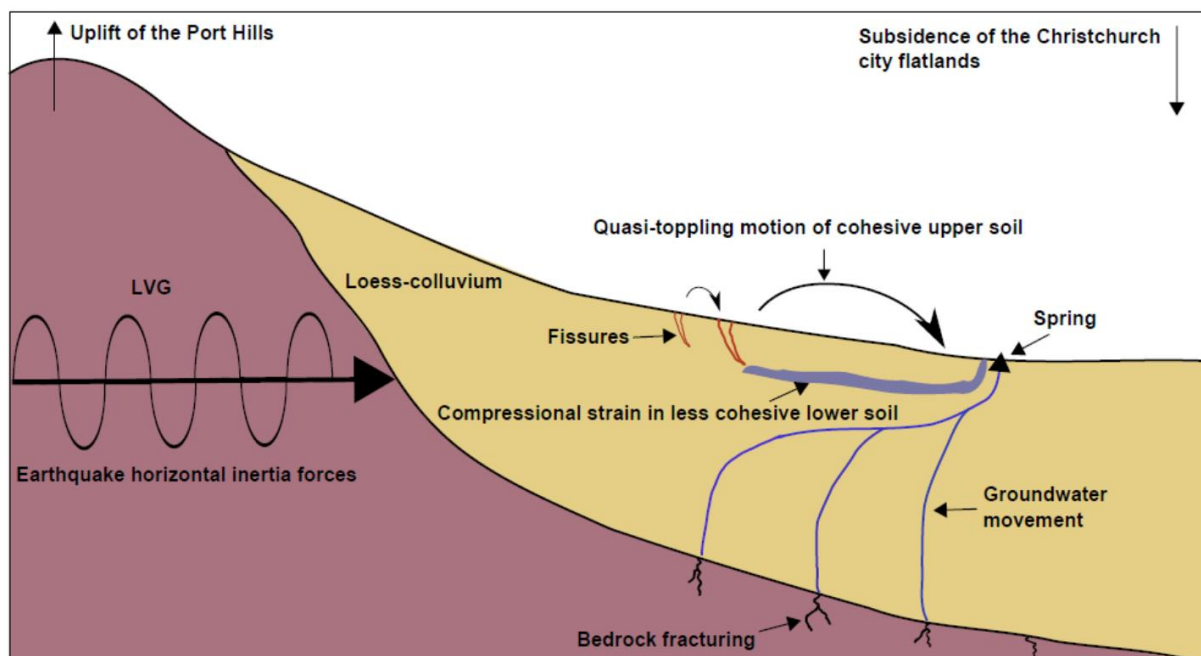
The most likely slope movement type is considered to be a quasi-toppling motion similar to that suggested by Stephen-Brownie (2012), but with slightly different mechanisms. The movement model presented in Figure 6.1 is considered to be the most realistic representation of the mode of movement for the Ramahana Road fissure trace. This model depicts the movement occurring as a result of tensile stress/strain developed due to 1) bedrock uplift of

the Port Hills relative to the Christchurch city flatlands; 2) horizontal earthquake inertia forces; and 3) the static shear stress of the slope. The extensional outward movement of the upper more cohesive soil is considered to have been a quasi-toppling motion downslope, and this movement has been accommodated by compressional strain in the underlying less cohesive soil.

The quasi-toppling motion hypothesis offers a good correlation to the recorded surface and subsurface features of the fissure traces at 17 Ramahana Road and Centaurus Park. More research is needed to test and confirm the mechanisms suggested in this thesis, but there has been sufficient evidence from this research to indicate that the ‘loess-slump’ hypothesis is not applicable to the Ramahana Road fissure trace.

Figure 6.1: Preferred engineering geological model for the movement of the Ramahana Road fissure trace.

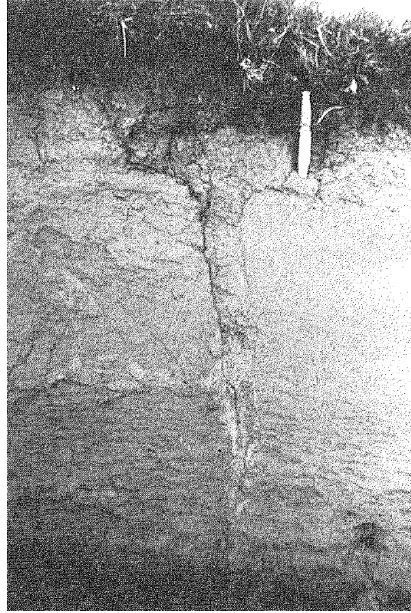
An alternative hypothesis might be that the fissure traces are the result of palaeo earthquake activity, and there are some similarities between the fissure traces formed after the Christchurch earthquake and those studied by Harris (1983); including the fact that they are open fissure traces and that they have low clay content within the fissured material. There are, however, many discrepancies, including their location: found on steeper, south facing slopes, and at a much greater distance from the Port Hills fault than in the fissures caused by the Christchurch earthquake; their size: they are much smaller features, being only up to 165 cm deep and usually 5-15 cm wide at the surface, but only up to 60 cm wide; their shape: they tend to be highly vertically orientated with little downslope curvature at the base; there are also many of them, and they are spaced quite closely together. See figure 1.2 for a photo of the palaeo fissures.

Figure 1.2: Infilled palaeo fissure in loess. After Harris (1983)

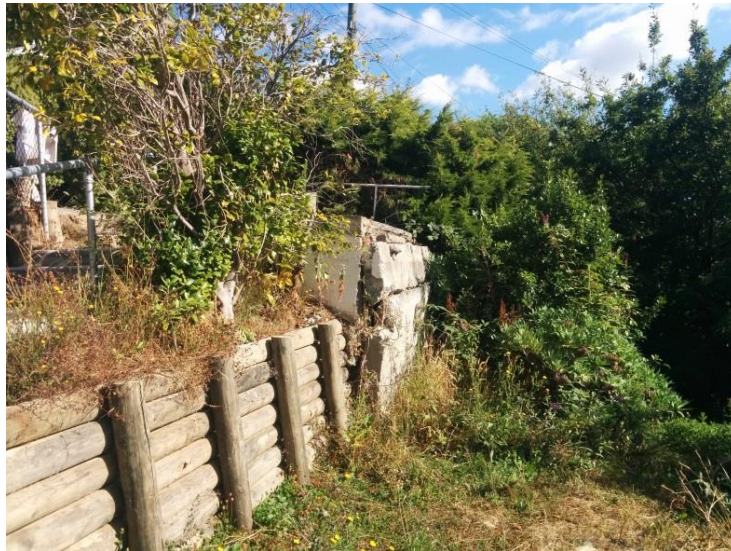
2.1.1: The cracked concrete pad in the extensional zone.

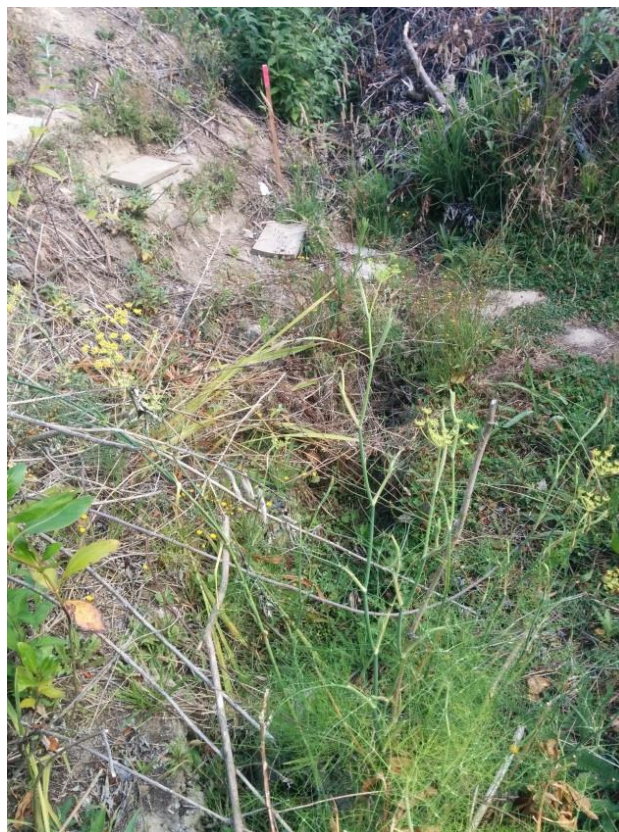
2.2.2: The main overgrown and in-filled, but undisturbed fissure trace.

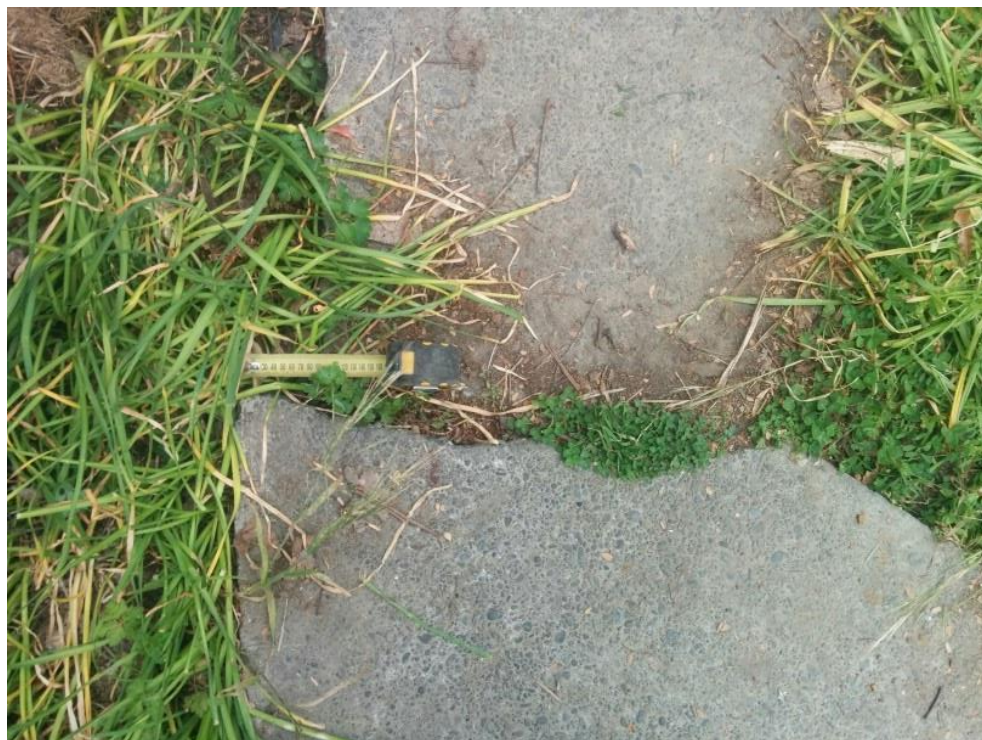
2.2.6: 100 mm horizontal and 50 mm vertical offset in concrete path in the valley floor.

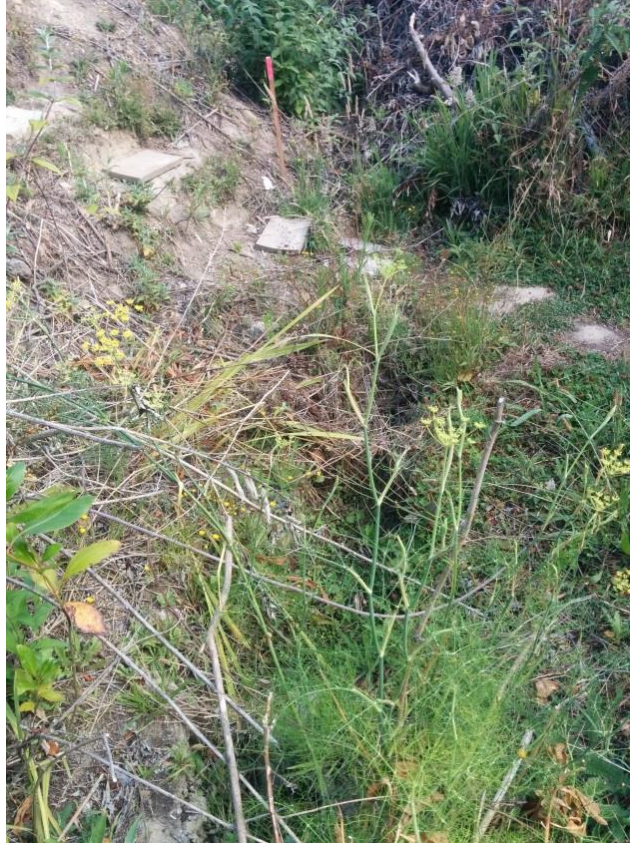
2.2.1. The condition and location of the fissure trace which was dug through by the digger at 17 Ramahana Road.

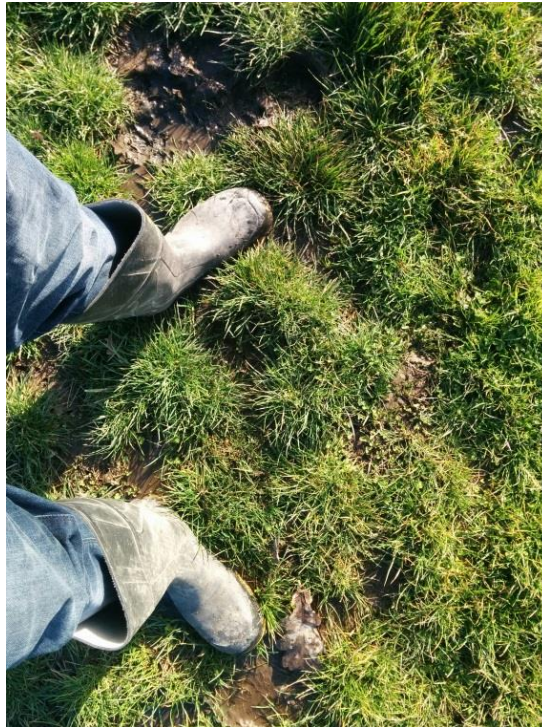
2.9.1: Looking down at the boggy ground.

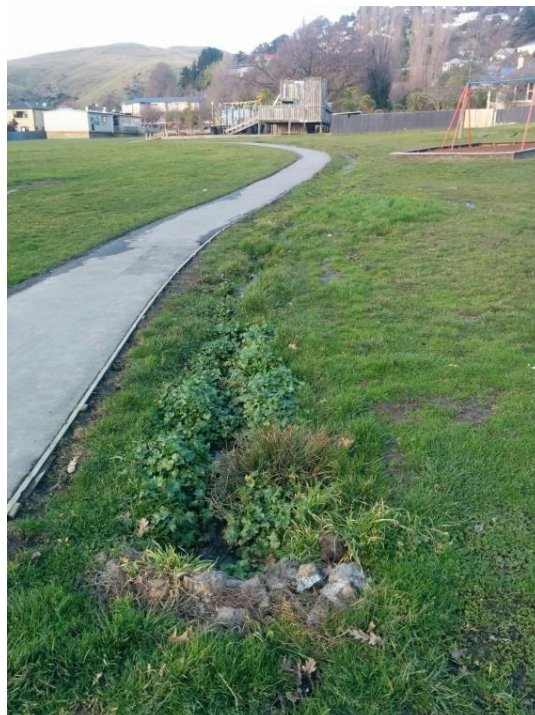
2.9.2: Ditch along path for surface water.

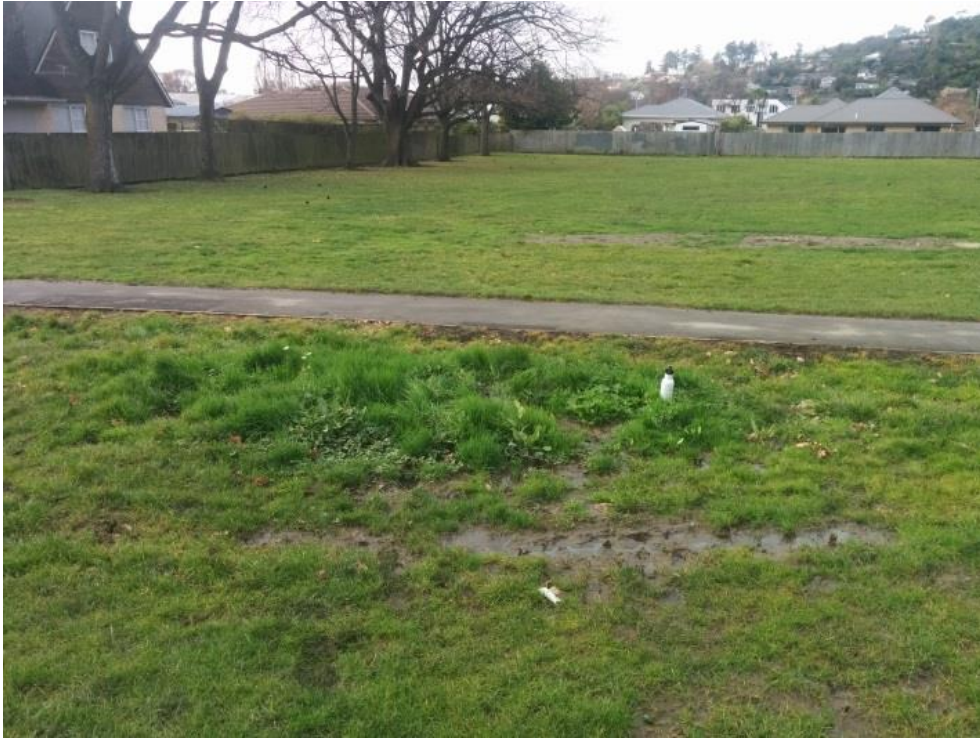
2.9.3: Very boggy ground where the spring is.

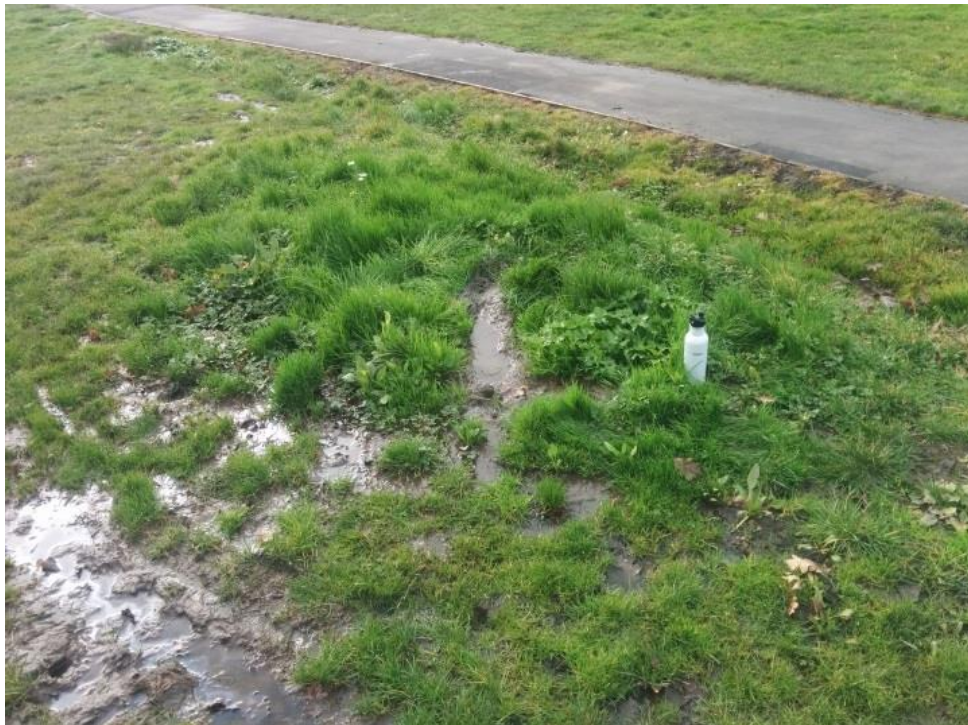
2.9.4: Close up of the boggy area.

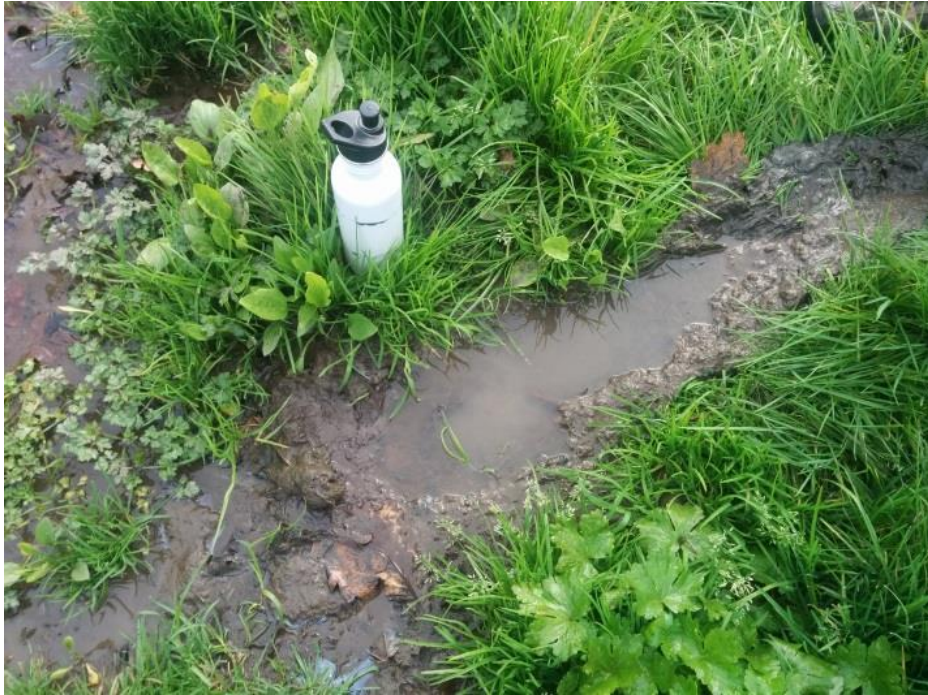
2.9.5: Close up of where the spring is seeping water to the ground surface.

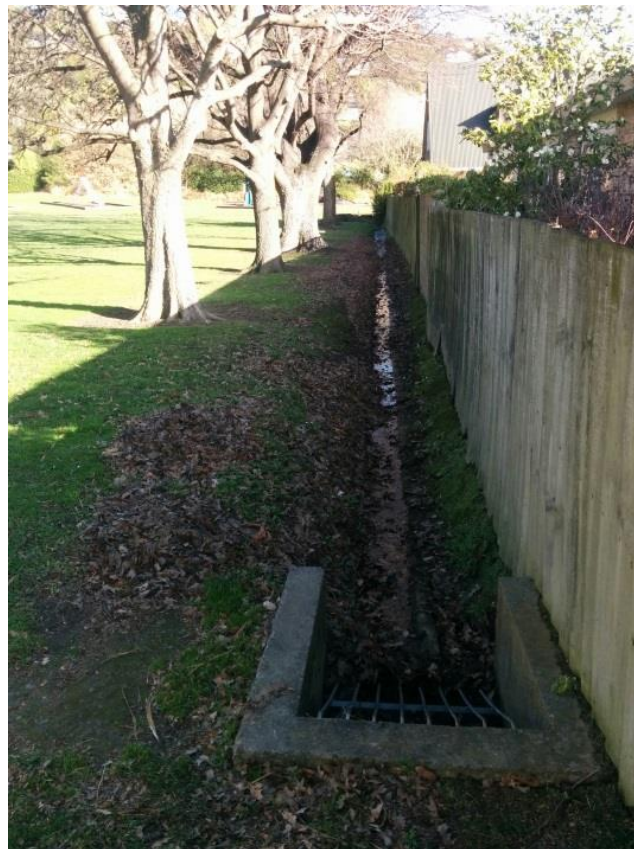
2.9.6: Ditch filled with stagnant water along the northern boundary of the park.

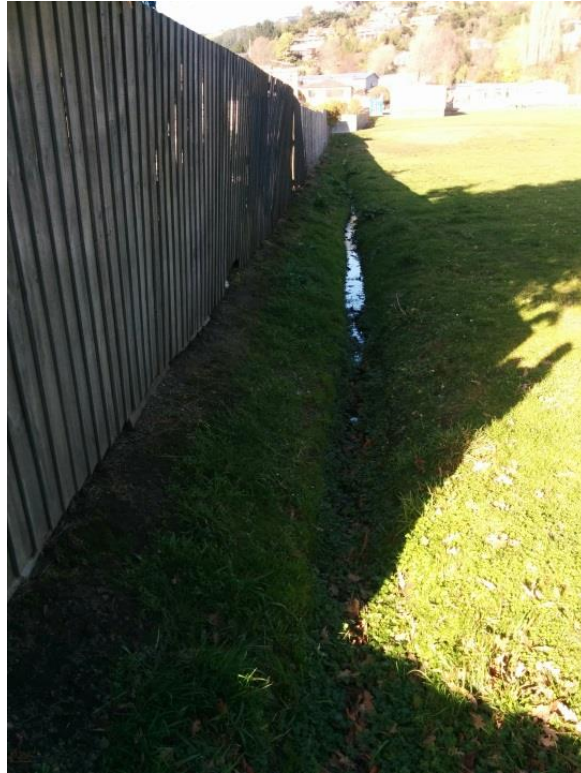
2.9.7: Ditch filled with stagnant water along eastern boundary of the park

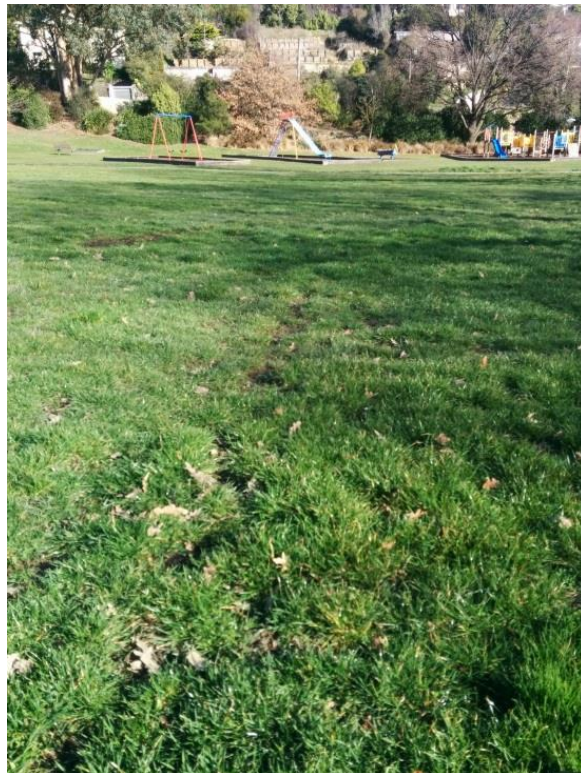
2.9.8: Boggy ground in centre of park, looking west towards Ramahana Road.

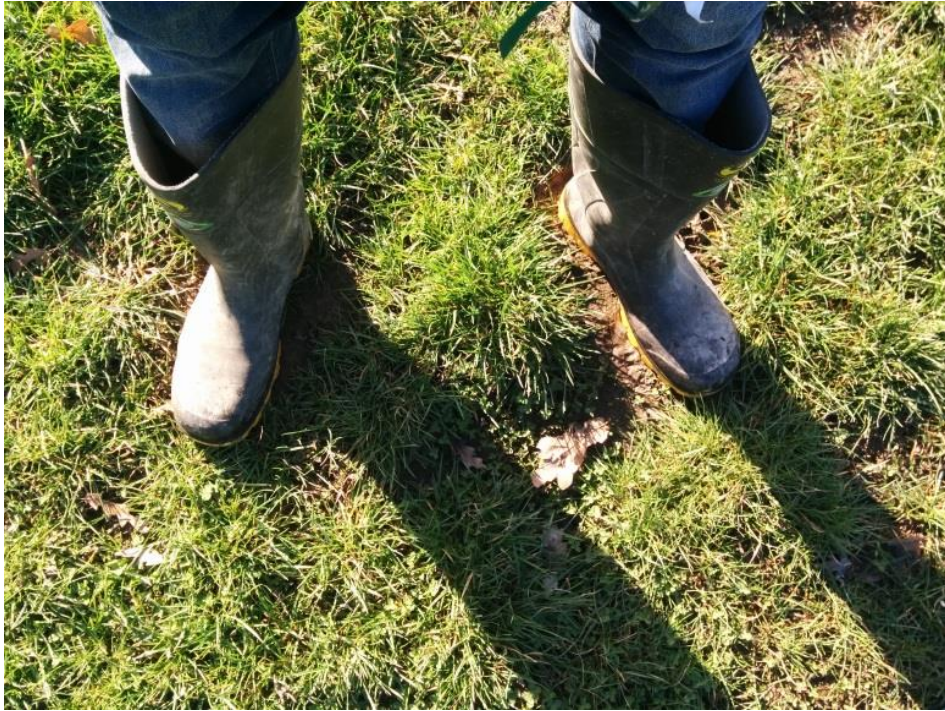
2.9.9: Looking down at boggy ground in the centre of the park.

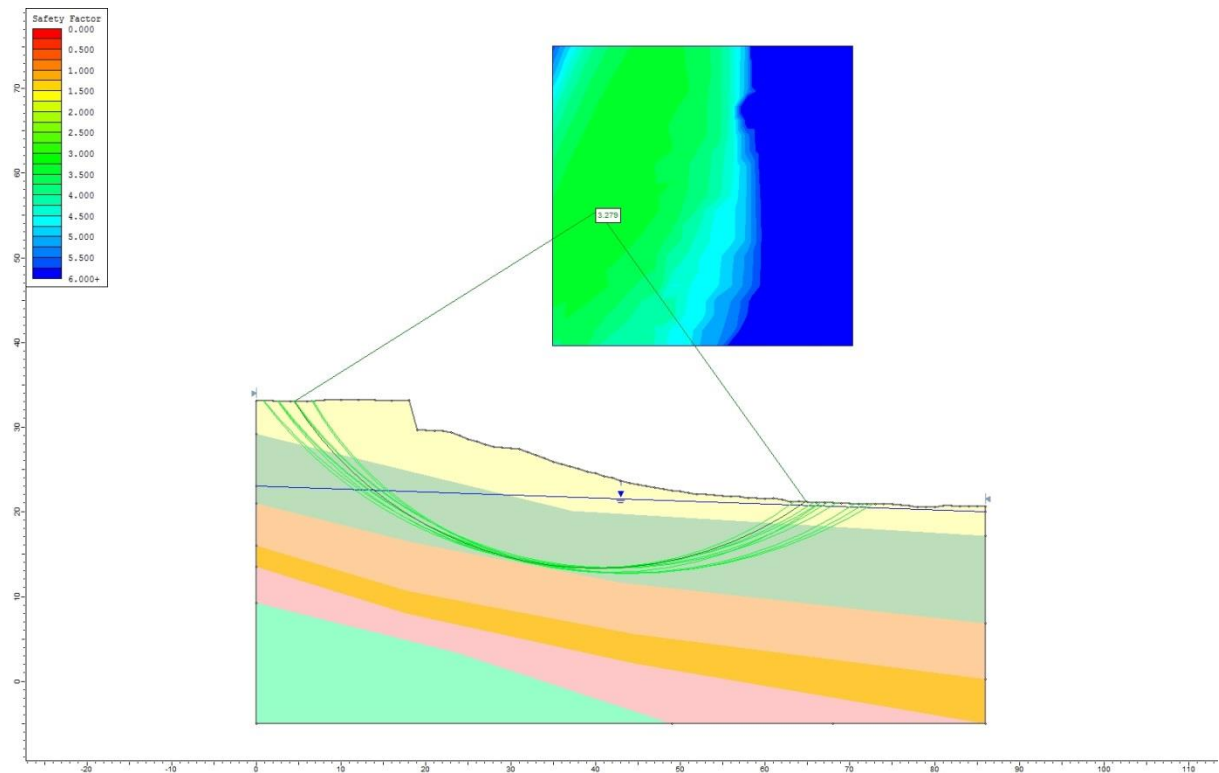
Figure 3.1: The 10 rotational slip surfaces with the lowest FOS in the layered model.

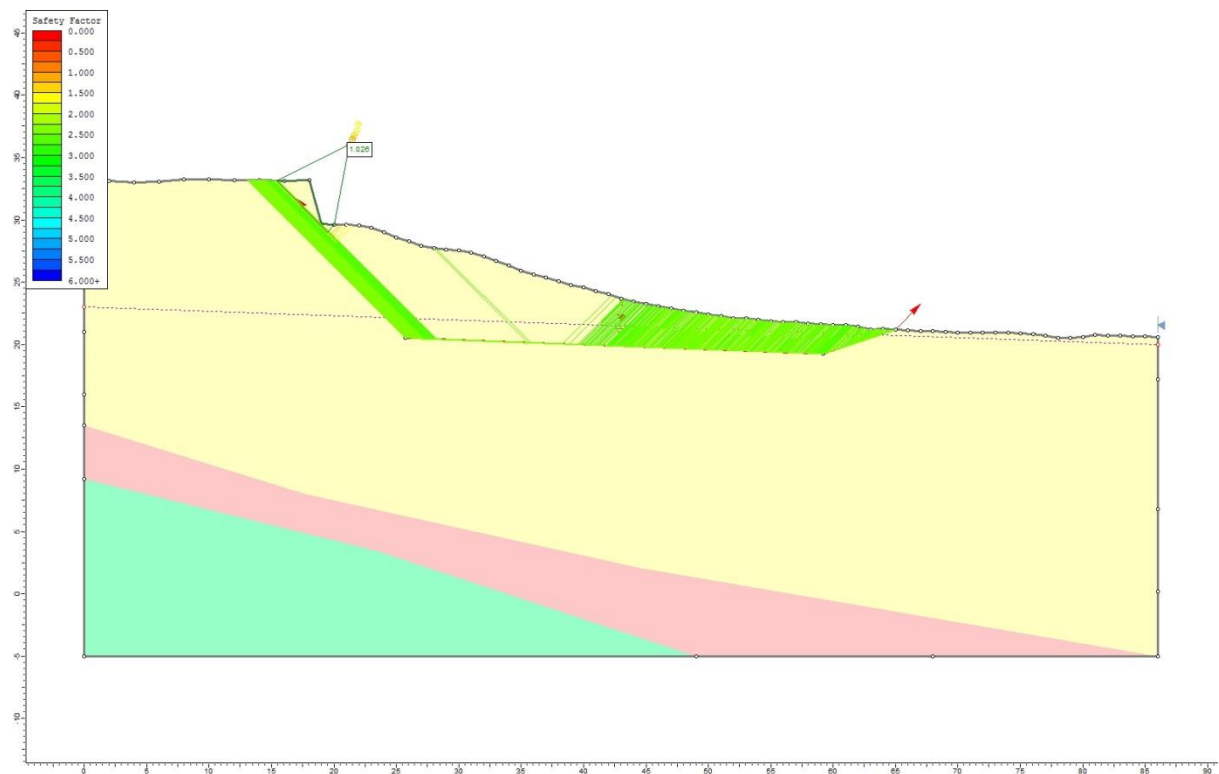
Figure 3.2: Translational slip surfaces with FOS <2.66 by Janbu method in the homogeneous model. The FOS has been filtered to <2.66 to find the lowest FOS failure surface that follows the fissure trace at 17 Ramahana Road.
